**Coastal Protection and Restoration  
Authority of Louisiana**

**2007/2008 Annual Inspection  
Report**

**SOUTH WHITE LAKE  
SHORELINE PROTECTION  
PROJECT  
(ME-22)**

May 28, 2008  
Vermilion Parish

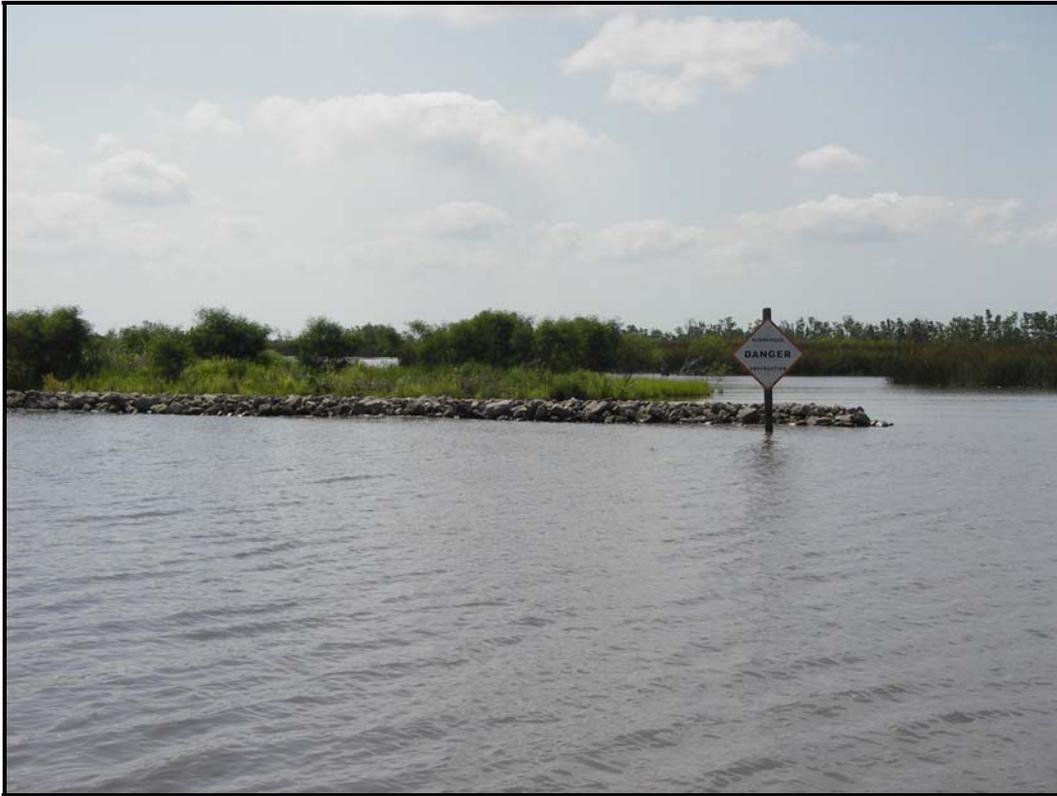
The rock dike is in excellent post construction condition. A few low areas were noted along Bear Lake where there was some initial settling during construction. These areas will be monitored during future inspections. Signage along the entire project is also in good condition. The spoil bank material placed behind the rock dike generated from the flotation excavation has approximately 90 per cent vegetation cover. (Photos: Appendix B, Photos 1 & 2)

**Photo 1,** west end of rock dike.

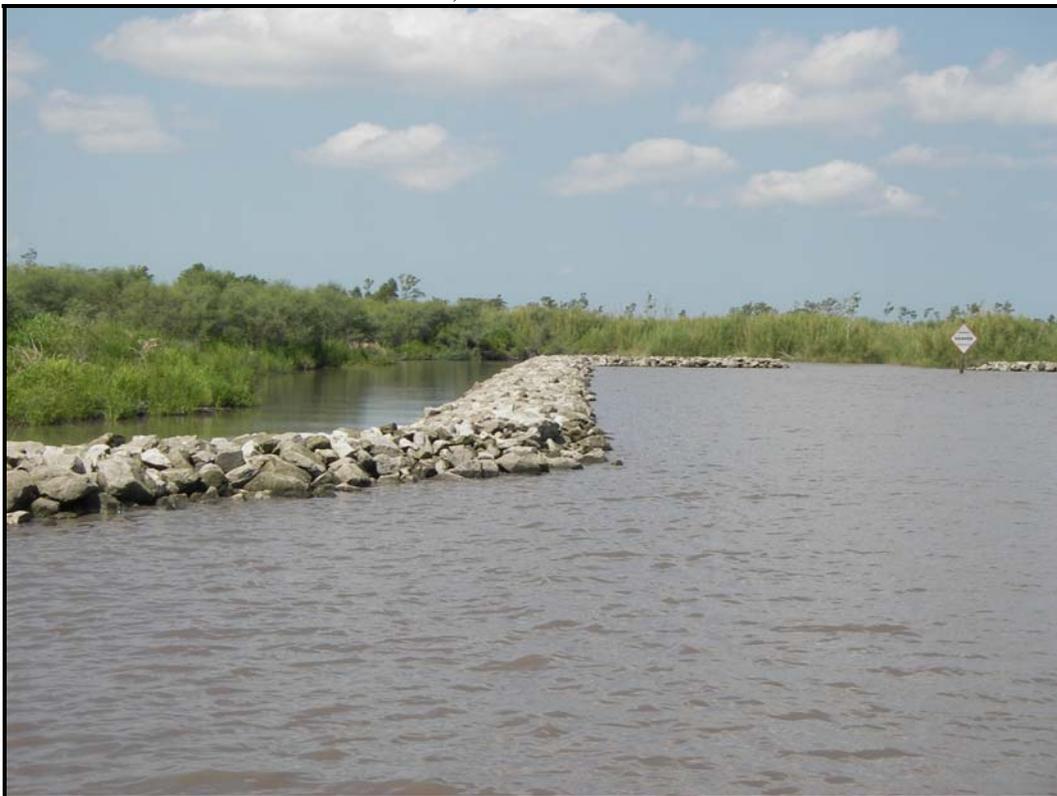
**Photo 2,** View of typical rock dike section, fish dip and signage.

Overall, the South White Lake Shoreline Protection Project is in very good condition and functioning as designed. It is recommended that the warning signs be numbered from one end of the project to the other in order to determine where your physical location is along the twelve mile long shoreline during an inspection.

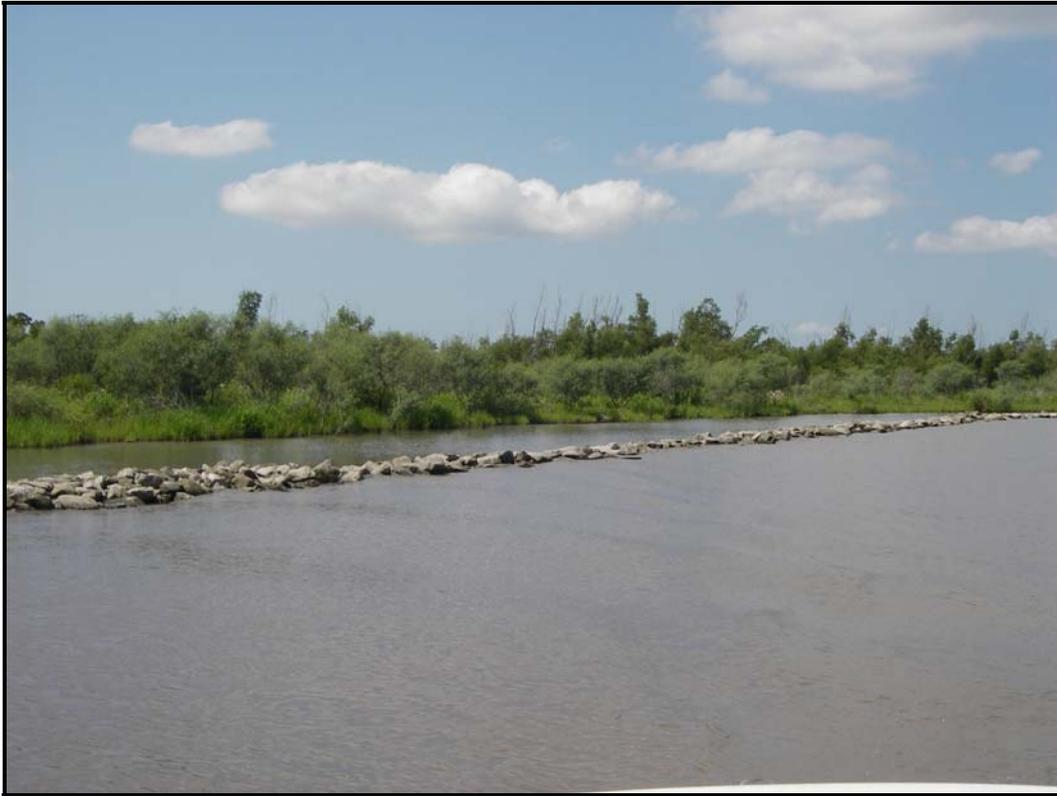
**Photo 3**, low section of rock dike in Bear Lake

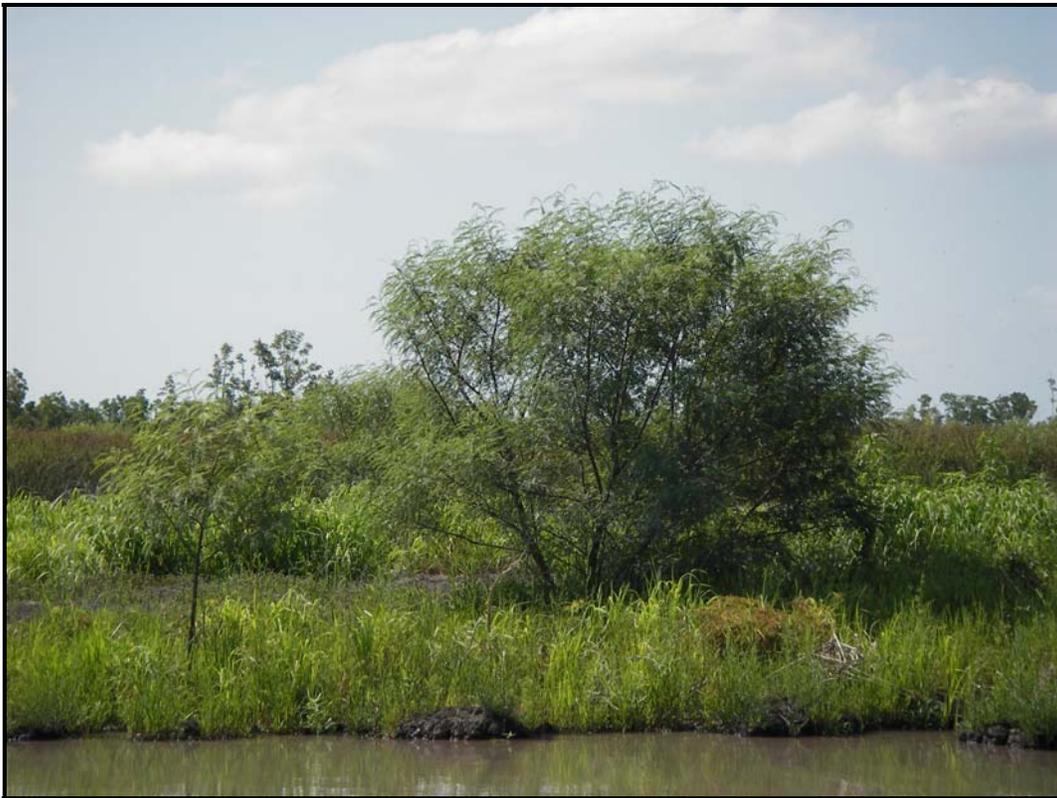
**Photo 4**, close up view of spoil bank behind rock dike showing vegetation.

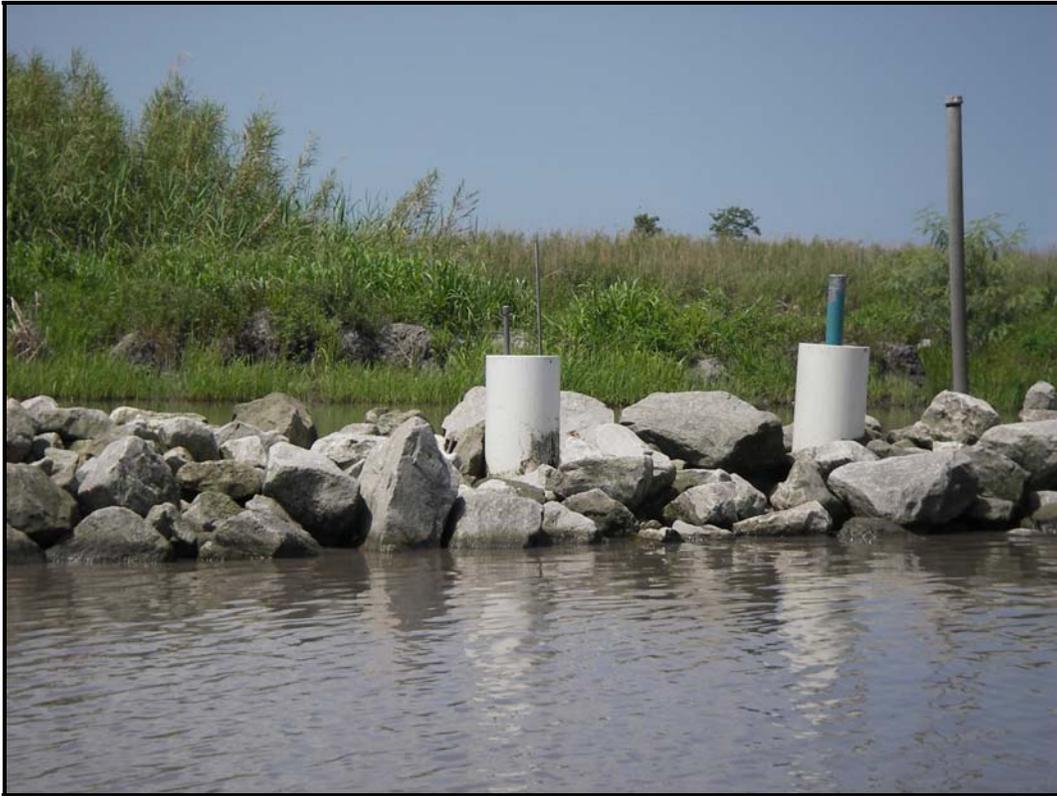
The six different demonstration areas are in good condition and do not appear to look any different than the rest of the project as far as crown width, dike elevation and side slopes. The various instrumentation devices at each demonstration section are intact. A request was made to get the monitoring data from these instruments from the USACE. (Photos: Appendix B, Photos 1 & 2)

**Photo 5**, view of instrumentation on one of the demonstration areas.

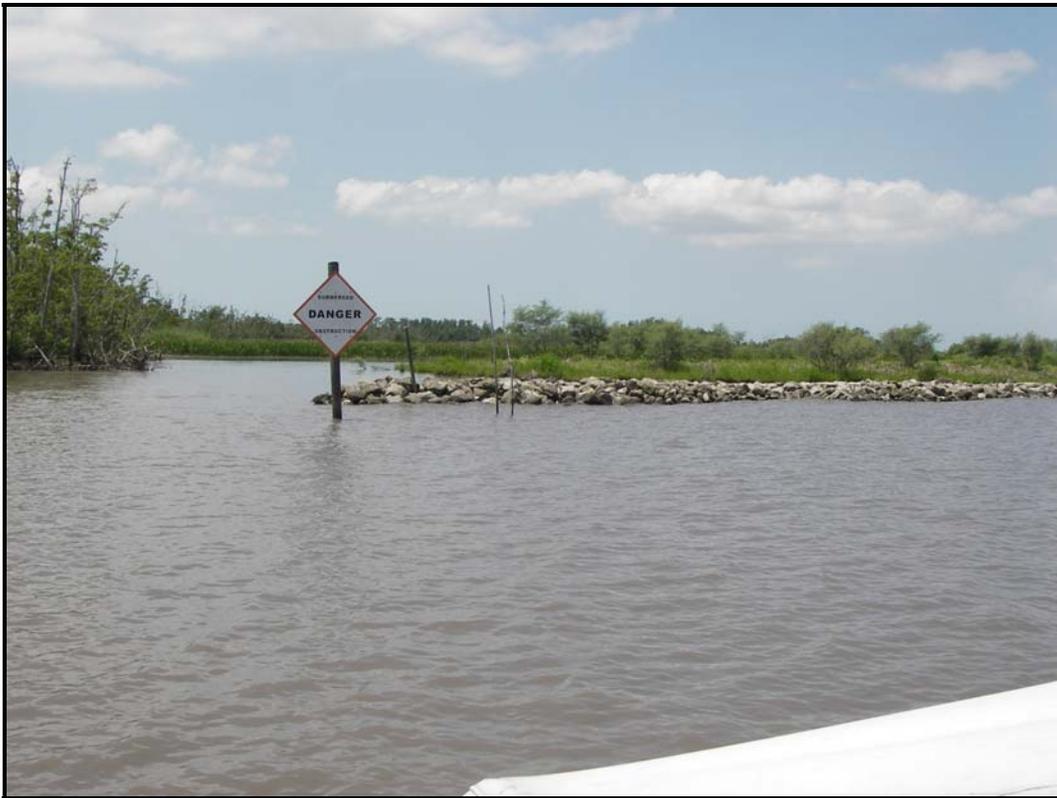
**Photo 6**, east end of the foreshore dike.
